**LENZIE MOSS MANAGEMENT PLAN  
2009 – 2014**

Prepared by Donaldson Environmental Consultancy Ltd  
In association with  
Dean Heward  
&  
Stuart Brooks

FINAL PLAN – JANUARY 2009

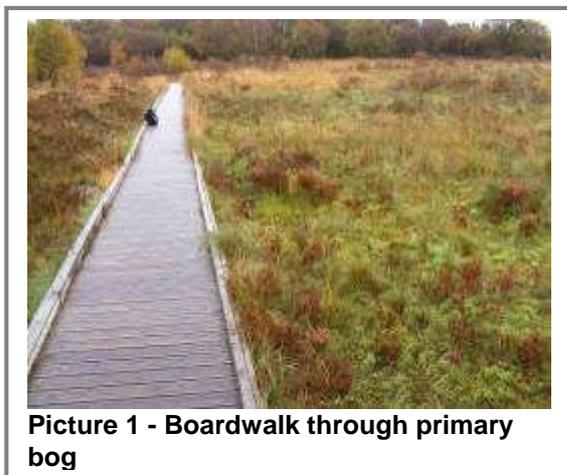
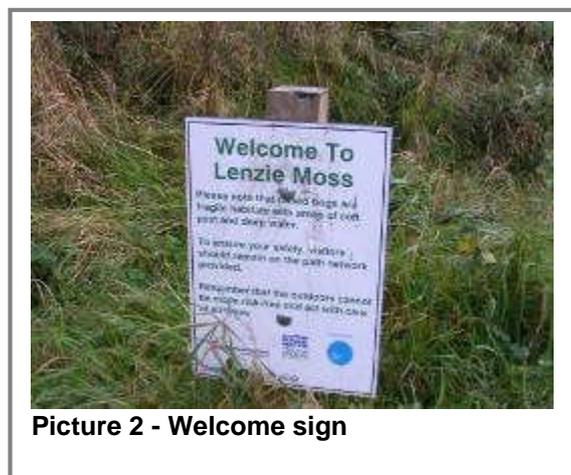
Small sections of the path have sunk in places and puddle after heavy rain. There are several bridges which cross over drains or wet areas, made of timber and hardcore. The path cuts through both woodland areas, rank grass and scrub habitats. The boardwalk is 1.0m in width and has two passing places with one seat.

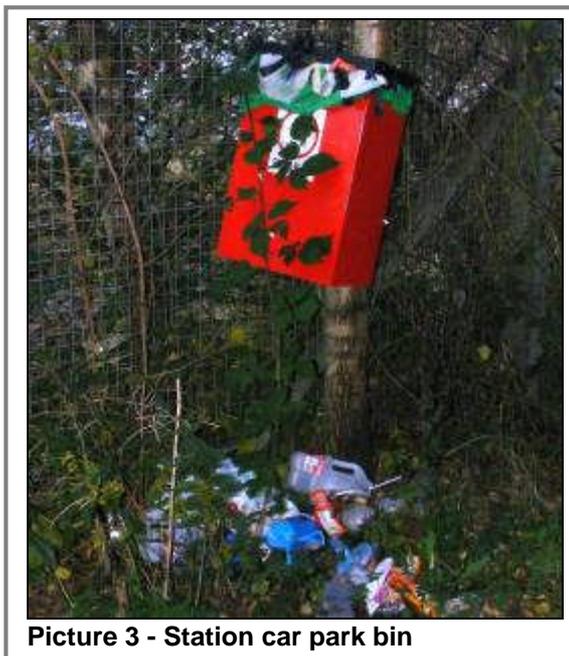
Picture 3 - Station car park bin

There are several dog bins at entrance points. The one at the railway station car park entrance is heavily used.

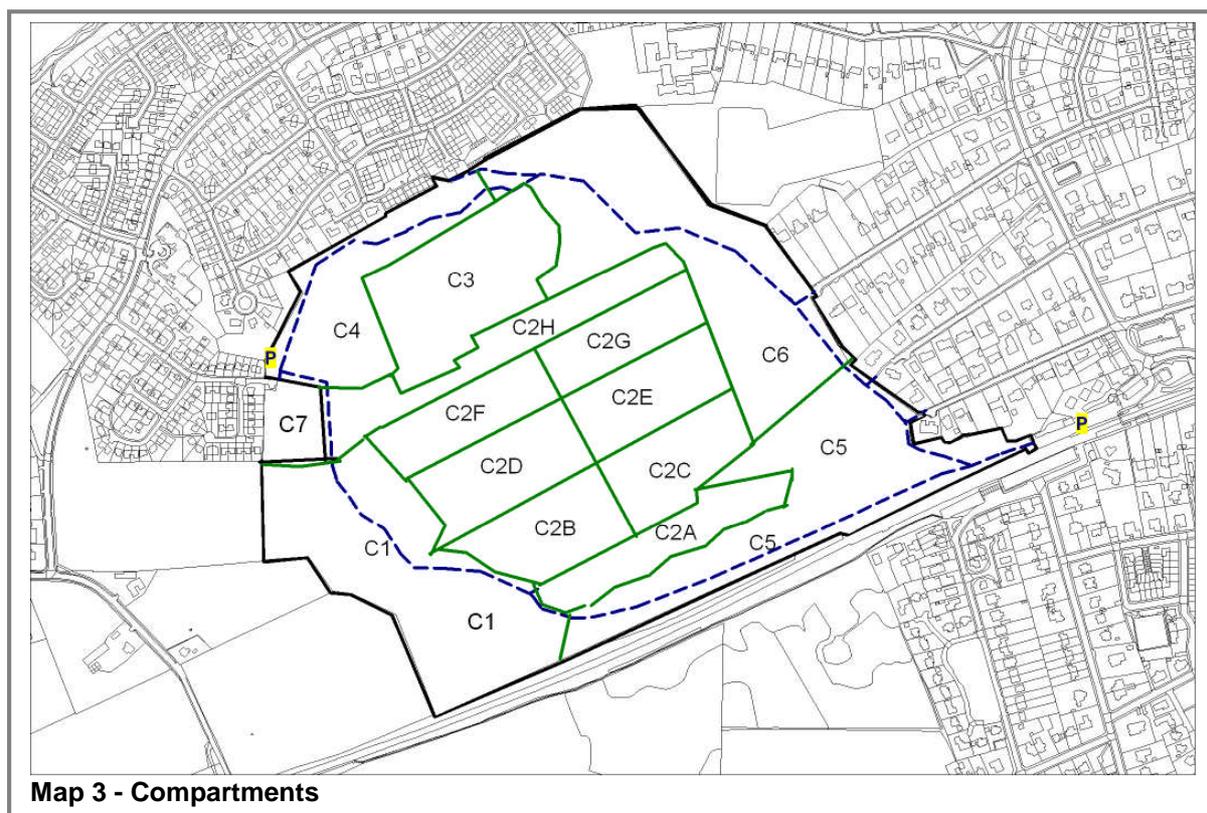
C1: The area of primary bog by the boardwalk, containing the bog rosemary.

Compartments 2 A to H comprise the previously cut peat field. The compartment boundaries are formed by raised baulks.

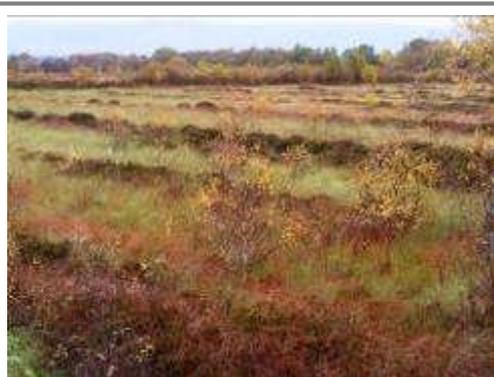
**Picture 4 - Baulks and cut over fields in C2A**

The central area is partitioned into nine irregular rectangular peat working areas which now form shallow basins (Compartments 2A to 2H). The compartments have raised 'baulks' of uncut peat around the margins and smaller linear partitions within the compartments.

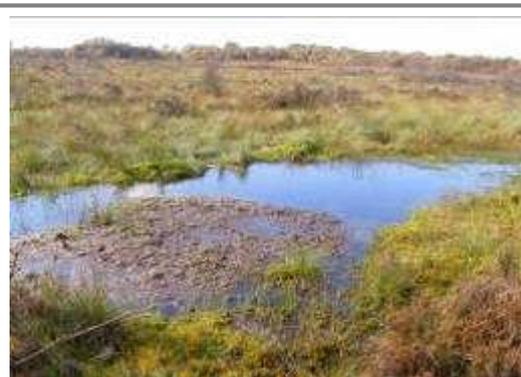
**Picture 5 - Ditch between C2D and C2E**

However, the drainage system installed to facilitate peat cutting is still active. This is an interconnected network which drains the whole of the site to 4 main outflow points. A separate but less extensive system is present on the uncut area. These drains with baulks divide the secondary bog area into compartments (see Compartment Map).

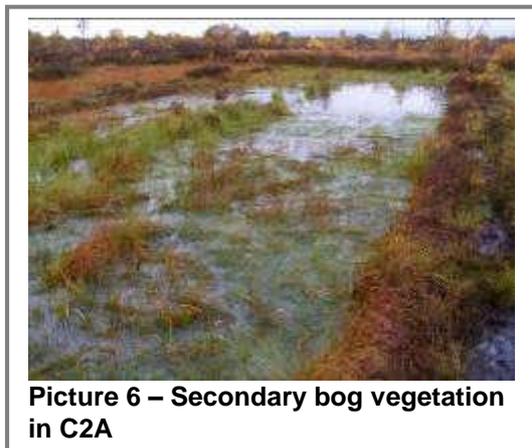
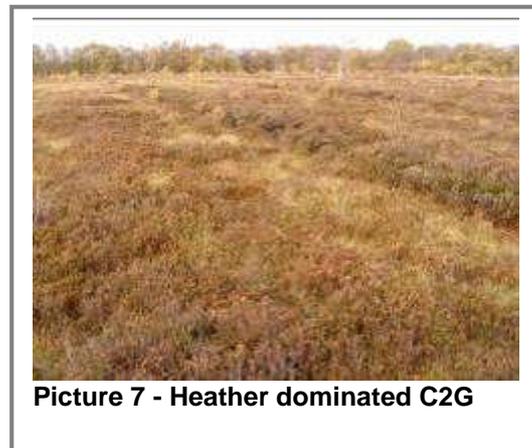
Compartments 2C, 2D and 2E are the wettest compartments, along with the northern area of Compartment 2A. For considerable periods of the year and after rainfall events, shallow open water covers large areas of compartments 2A, 2D and 2E. Compartment 2H is reasonably wet, while Compartments 2F and 2G are notably drier, with extensive heather growth. Compartment 2B is drier with dense birch growth.

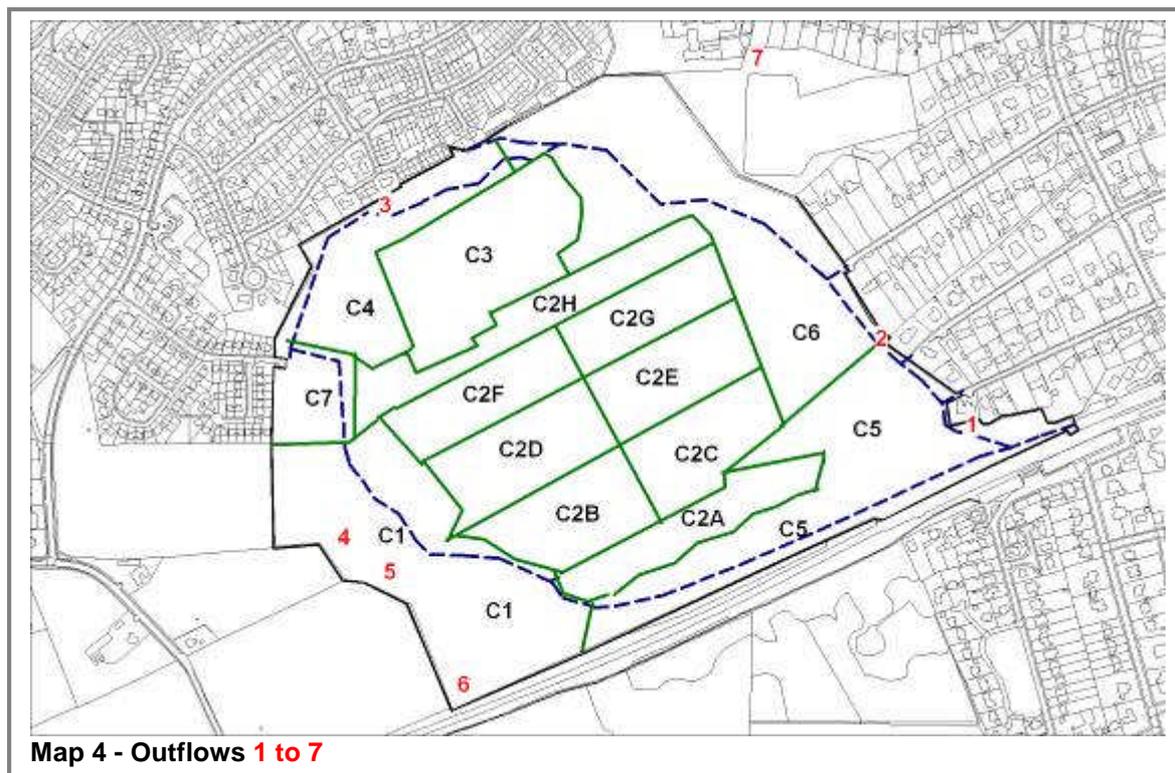
See full map in Appendix 1

Seven outflow points have been identified (see map below):

- 1.** An underground pipe beneath gardens backing onto the path leading to Lenzie station. This drain takes water from the ditch which flows from Compartments 2A and 2C. The ditch / drain point had a metal grill installed in 2008 to help stop the drain blocking with debris. The grill is close to the end house of Heath Avenue, and the drain is a 300mm pipe.

Drains 4, 5 and 6 appear to be drainage ditches, but they rise towards the west. It appears that water collects in the ditches and infiltrates to the surrounding area over time.

For most of the site except the western margin, water that percolates through the peat layer drains away in an easterly direction. Walrag data from the hydrology study also shows that there is a gradient of the water table running from west to east (Bone, 2007). Surface water and shallow groundwater are intercepted by drainage ditches and flow in a variety of directions to outfall points around the site, but most water outflow occurs through outfalls 1 and 2. Data indicates (Bone, 2007) that the flow in drain 2 is ten times that of drain 1.

Although after rainfall events the flow of drain 7 is three times that of drain 2, the surrounding conditions, (rugby fields, hardcore and old rubbish tips) suggest that this is due to faster run off from those areas.
